Investigation of Spray Seal Pavement Failure at Caloundra Tennis Centre

ABSTRACT

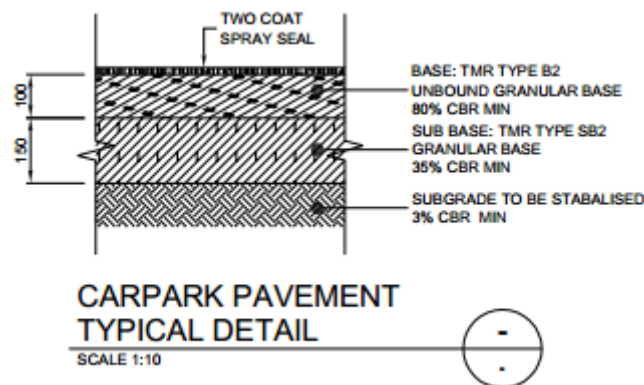
FIGURE 1 Car Park Base Design

The carpark extension was scoped as a low use area with no heavy vehicle use, to be designed with cost effectiveness in mind. The carpark extension was to cover a new 580m² area and tie in to the existing carpark. Geotechnical Investigations and reports done by others found a subgrade California Bearing Ratio (CBR) of 3% existed in the area of interest. The final pavement design consisted of two base layers with a two-coat spray seal. A 150mm sub base or TMR type SB2 was specified with a minimum CBR of 35%. Above this a 100mm unbound granular base with a minimum CBR of 80% was specified with a two-coat seal to seal the pavement. The car park base design can be seen in Figure 1.

Tying into the existing carpark pavement was specified with the granular base overlapping the existing pavement by 300mm and the spray seal overlapping the existing pavement by an extra 300mm with a total of 600mm overlap. Carpark drainage was accomplished with a 100mm slotted agg pipe and sock at 1:200 fall behind the kerb and channel surrounding the pavement. The pipe is situated in a trench of 10mm single size aggregate at the edge of the pavement layer.

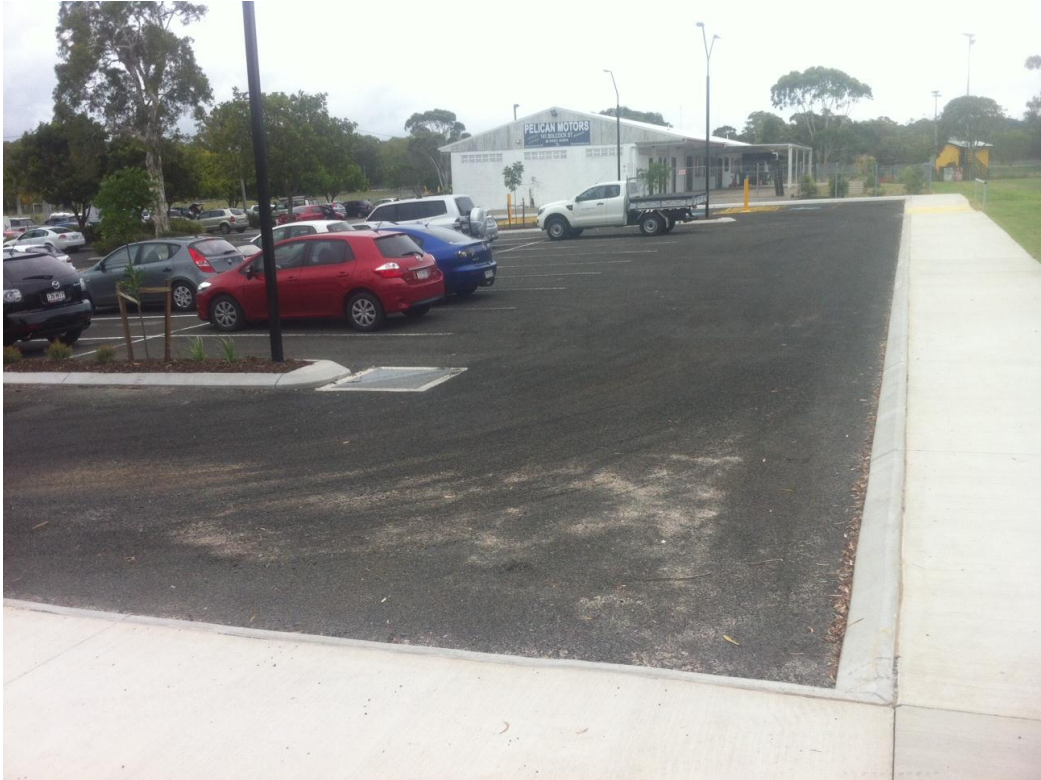
Figure 2 Pavement Failure at Caloundra Tennis Centre

The pavement was deemed ineffective by the client, in this case Sunshine Coast Council, within 3 months of the two-coat seal being laid. The failure was documented and photographed as having excess loose gravel material on the surface with an ineffective binding layer. Failure of the pavement can be seen in Figure 2 and 2. Figure 3 shows a close up of loose gravel formulating in piles, particularly around the turning lines of vehicles. Although excess gravel is expected on a two-coat seal pavement, the volume of gravel is expected to be minimal and this far exceeds the expected amount. The contractor criticised the design of the pavement, stating that a two-coat seal should not be used in car parking situations.

The aggregate sizes utilised in the construction was a 10/7, which differs from the preferred combinations of 10/5 or 14/7 as nominated in Austroads AP-T236-13 Section 1.5. Austroads recommends the secondary layer of aggregate should have a size no more than half the size

used in the first layer. Using a secondary aggregate size of more than half the primary size can lead to an inadequate binding of aggregate. The top layer aggregate was spread at a rate of $180\text{m}^2/\text{m}^3$ which is much less than the $250\text{m}^2/\text{m}^3$ set out in Section 2.3 of Austroads AP-T236-13.

The binder utilised was an AMC7 which requires a minimum 3 days of curing prior to sealing of the road per Austroads AP-T236-13 Section 2.2.7. The sealing was completed immediately after the binding layer was put down which diminished the binding of the aggregate.

The binder was laid at an application rate of $1.2\text{L}/\text{m}^2$ which is slightly less than the recommended $1.3\text{--}1.5\text{L}/\text{m}^2$ for 'cutback' bitumen binder covered in section 2.2 of Austroads AP-T236-13.

All of the elements of construction that differ to the required specification can contribute to an inadequate binding of the aggregate. Although each individual element may not have caused failure by itself, each difference between the construction method and the required specification contributed to the overall loss of bonding between the binder and the aggregate resulting in an excess of loose aggregate and a seemingly brittle pavement.

After the pavement was laid and it was noticed that the pavement was not performing as expected, it was suggested by Be Collective that a light sweep was undertaken to remove any excess gravel and an additional roll be carried out to further compress the layers per *AAPA Pavement Work Tips: Sprayed Sealing – Surface Enrichment*. The sweeping was not carried out by the contractor as they believed that sweeping the loose aggregate would expose the bituminous layer underneath and compromise the surface.

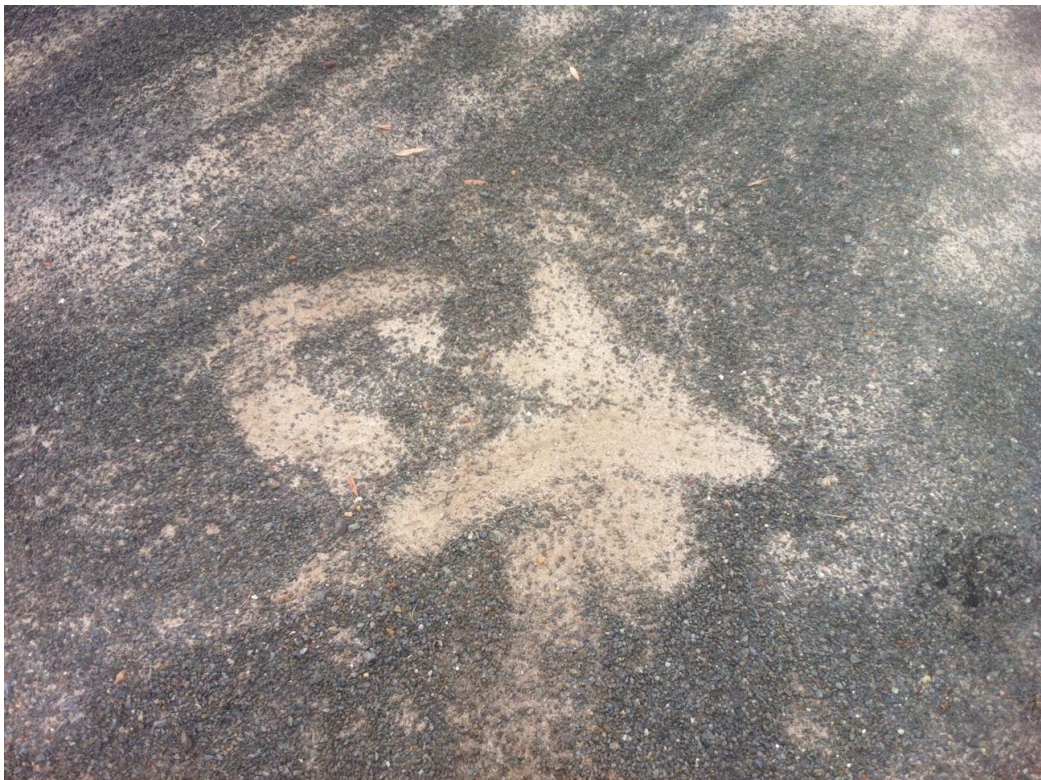
Figure 3 Pavement Aggregate Pooling around Turning Circles and Easily Removed
